MATERIAL SCIENCE

Dealing with Field Failure of Plastic Building Products

15 May 2023

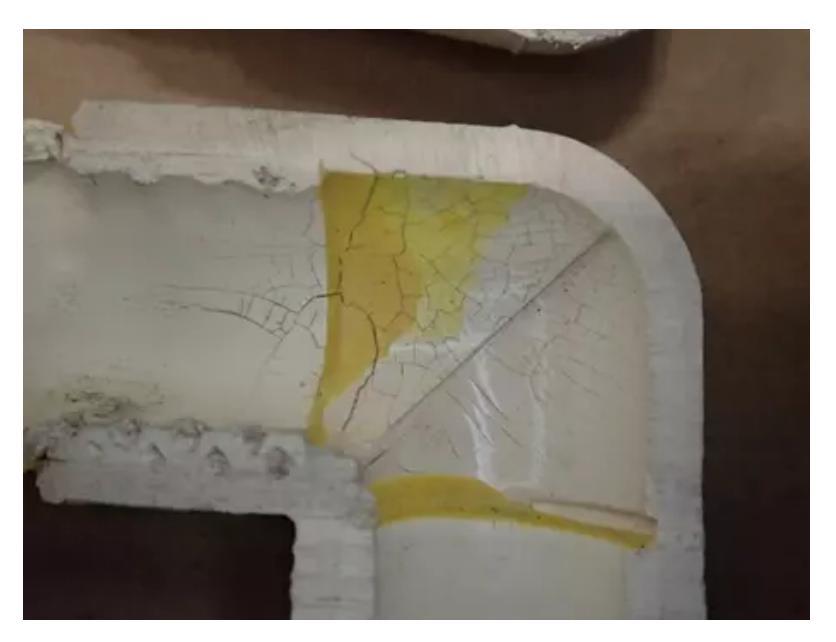
Photograph 1: Interior cracking on CPVC joint exposed to POE oil

PVC/CPVC is generally not recommended for use with most solvents (soluble or insoluble) including ketones, ethers, furans, esters, alcohols, and aromatics. The solvents can be absorbed into the CPVC substrate and lead to softening of the CPVC pipe. Cases of CPVC pipes used for fire suppression systems have been reported to fail due to accidental contact with drywall sealant or an anti-freeze agent that contains esters. Polyolester (POE) oils are another contaminant that can result in the degradation of CPVC pipe. While POE oils are not a typical constituent of domestic water supplies, remnants of the oil can sometimes be found within iron pipes or heat exchangers. It has been observed that, even at low levels, POE oil can lead to progressive cracking failures within CPVC pipes (Photograph 1)

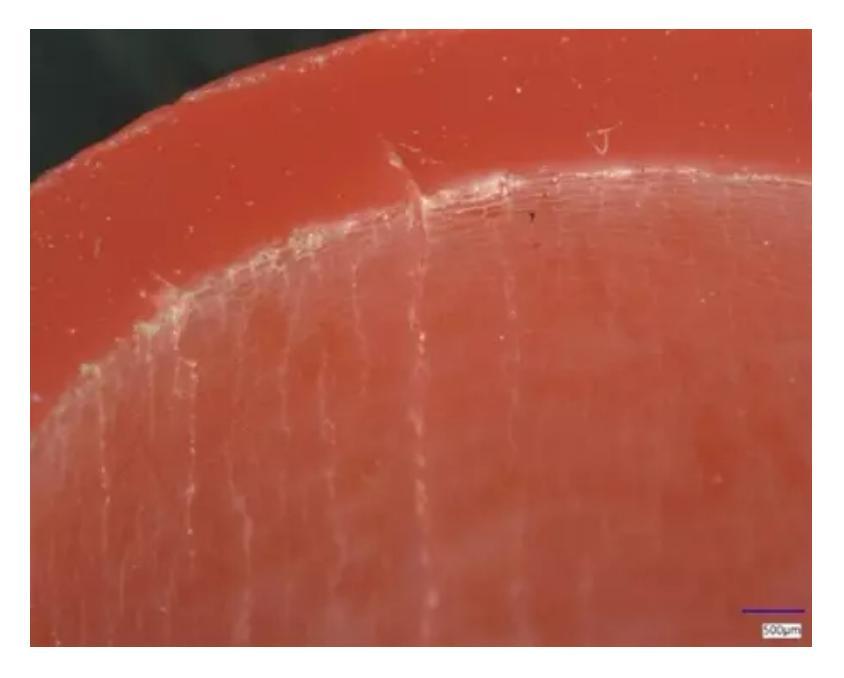
Photograph 2 - Longitudinal cracks on inner surface of PEX pipe

So, it is always good practice to consider the four factors before rendering any conclusion. But, sometimes, even after taking into account all of the factors, exceptions can still occur. One good example entails PEX water supply pipes. ASTM (American Society for Testing and Materials) Standard F876 establishes the performance requirements for PEX pipes. PEX manufacturers whose products pass the F876 requirements normally warranty their products for at least 25 years of field life. Yet, periodic chlorine spikes in potable water and local water quality could still lead to premature failure of the PEX supply lines. Photograph 2 and Photograph 3 show a PEX pipe degrading over time in a chlorinated water environment. One can see the initiation and propagation of longitudinal cracks due to environmental stress cracking. The hydrostatic water pressure intermittently applied on the pipe, coupled with the chlorine attack, has then caused the inner surface to develop surface and through-thickness propagating longitudinal cracks on the pipe. The sad reality is the pipe has been in the field for less than 10 years.

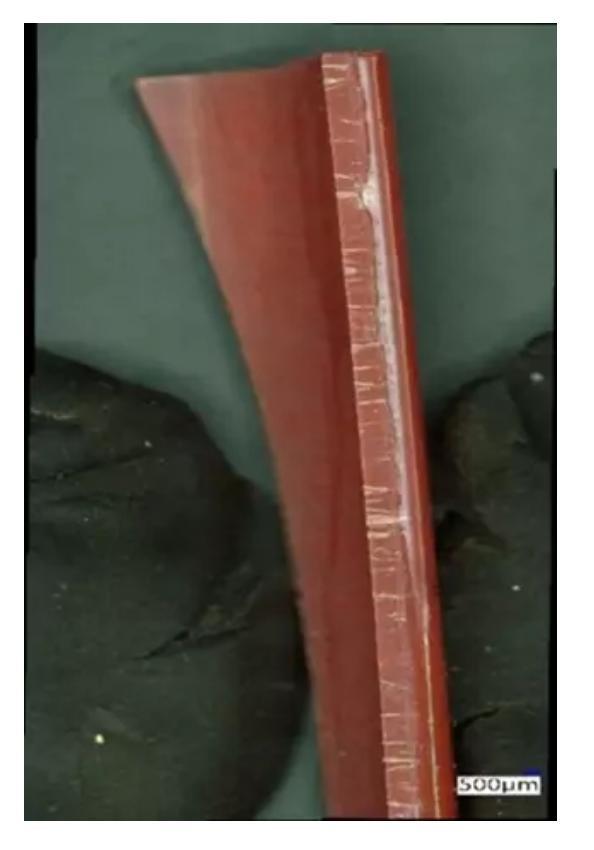
Photograph 3 – Opened longitudinal cracks
